Experimental study of the liquid jet-induced loads following a wave impact on MarkIII corrugations

Olivier KIMMOUN, Guillaume DUPONT & Fabien REMY (Ecole Centrale Marseille/IRPHE)

Multiphase 2017 – ENS Cachan – 16-18 October 2017

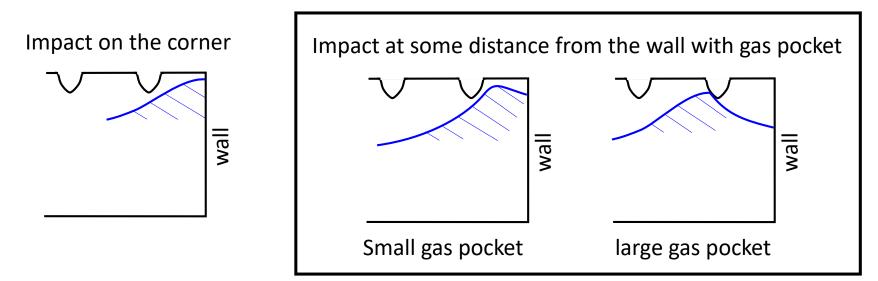
Wave Impact on an instrumented corrugated ceiling

Separation of the flow at the top of the corrugation – creation of a jet

Reattachment of the jet on the ceiling – propagation of the building jet

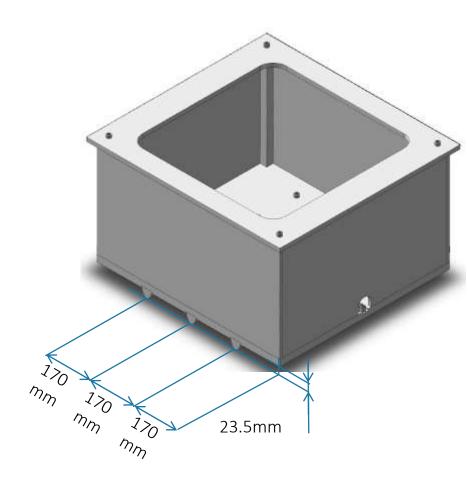
Experimental setup – 1st campaign

corrugated ceiling

Design by Arnaud Landure – GTT

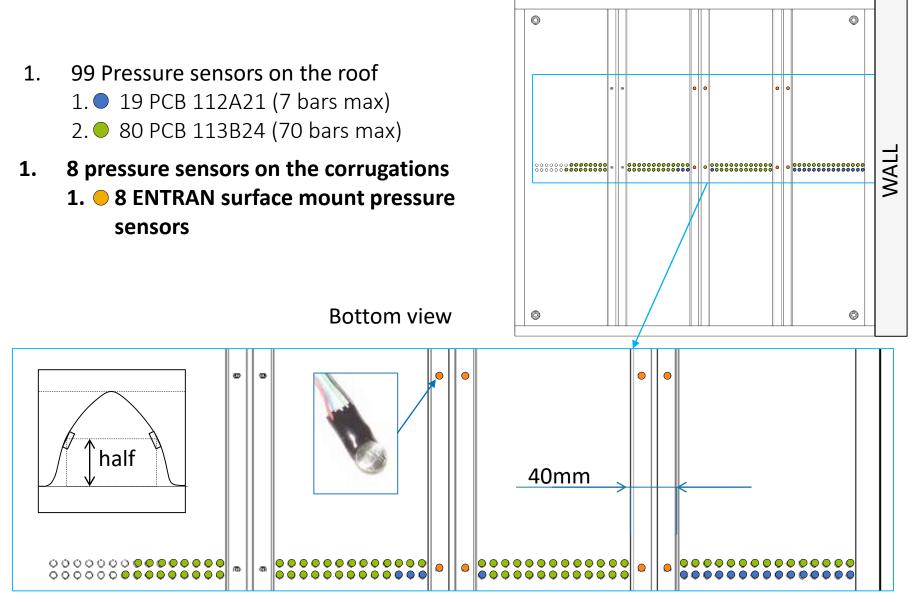
Experimental setup – 1st campaign. Corrugated ceiling

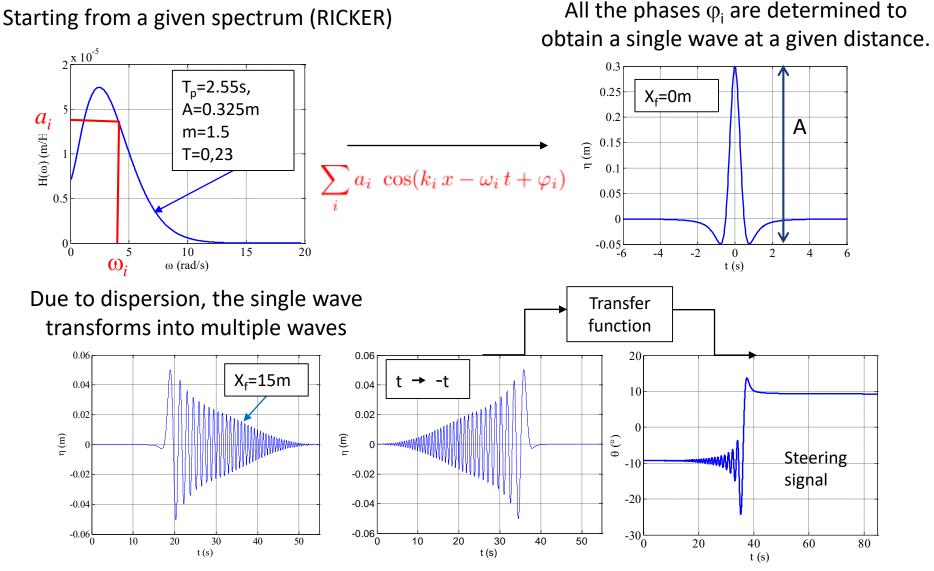
The classical space-time focusing technique

By reversing the time, this wave group leads to the single wave at the distance $X_f=15$ m

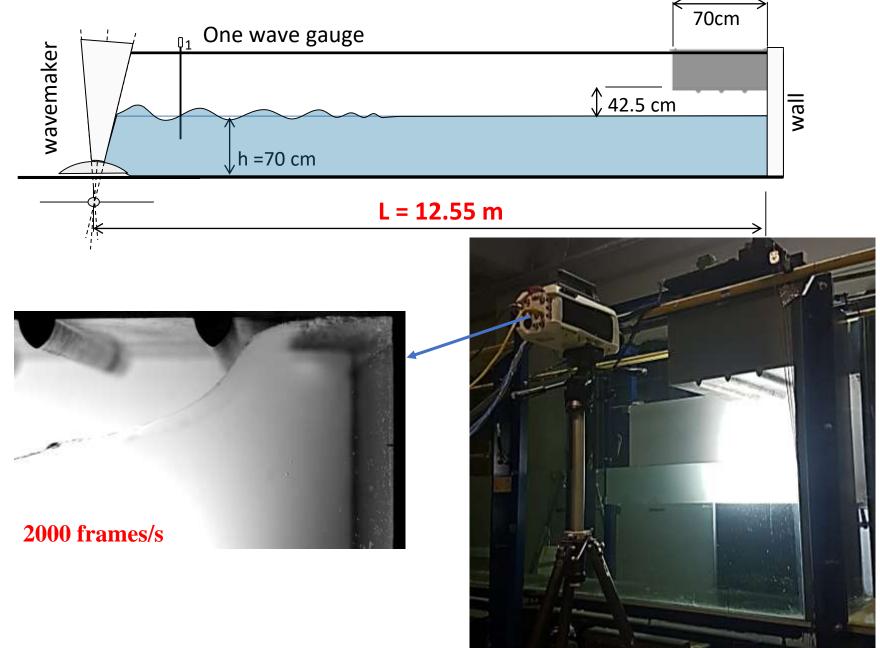
Experimental setup – 2nd campaign

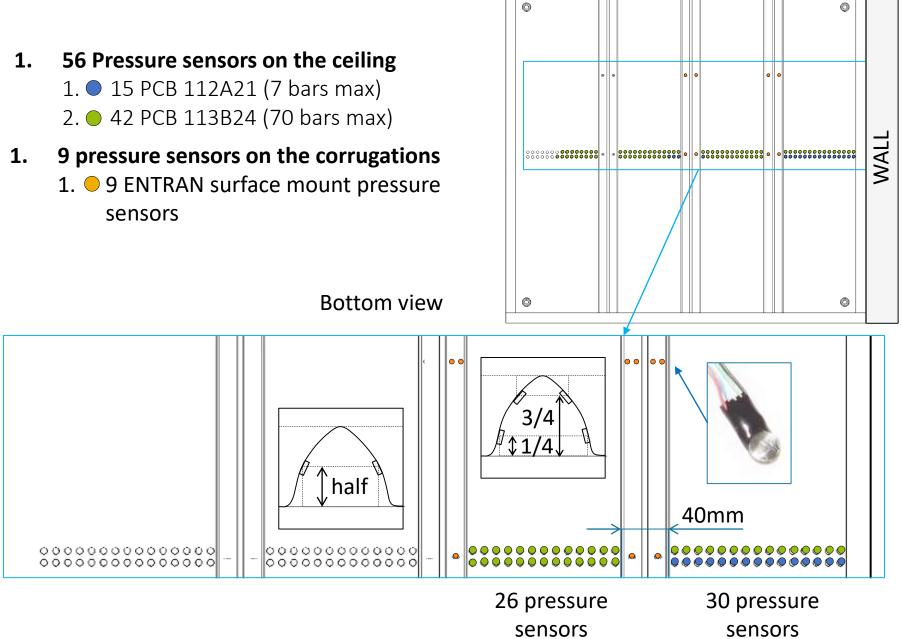
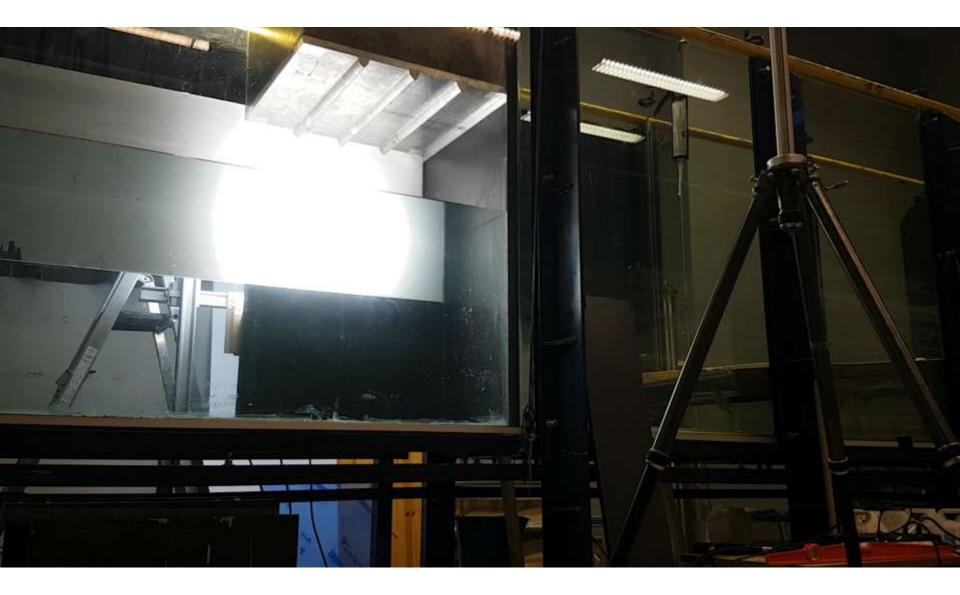
Corrugated Ceiling. 2nd campaign

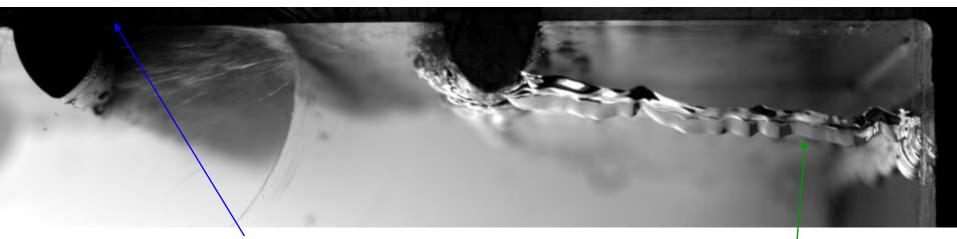
A test to calibrate the ENTRAN pressure sensors

Test n°24, T₁=2.617s, H₁=0.285m, x₁=x_{wall}+0.85m, T₂=1.825s, H₂=0.16m, x2=x_{wall}-0.1m

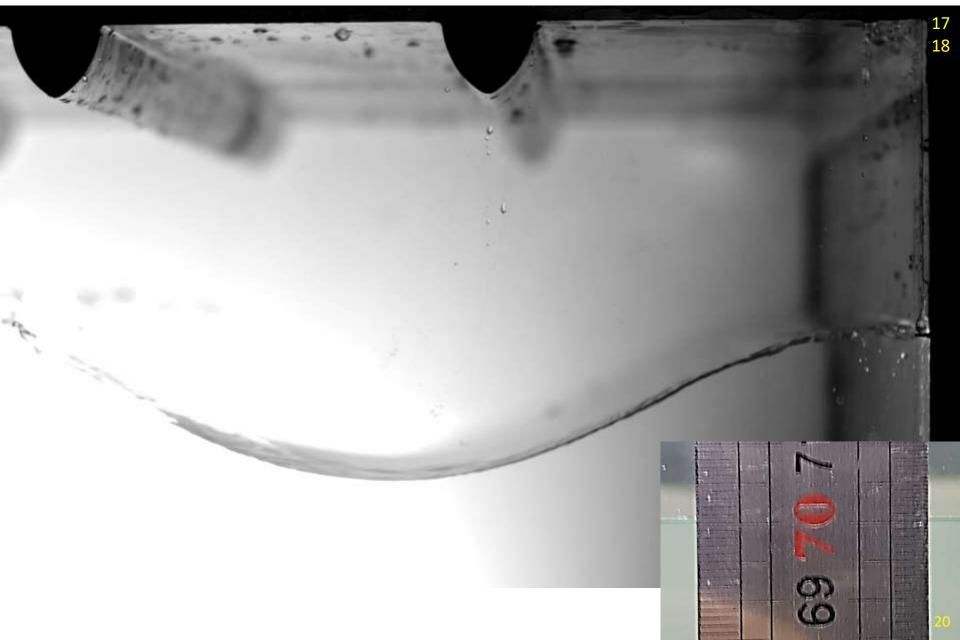
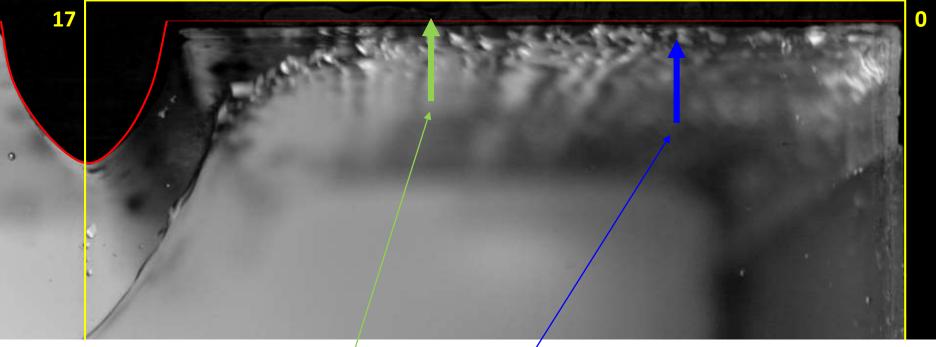
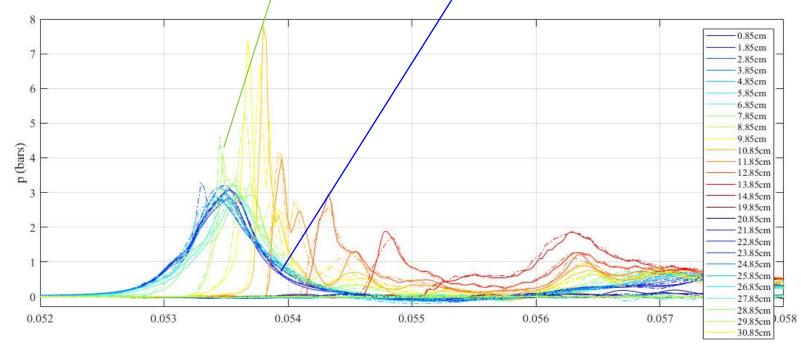
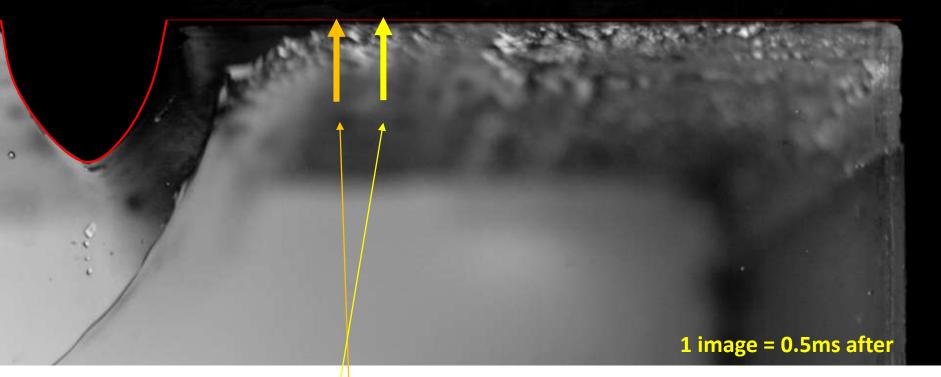
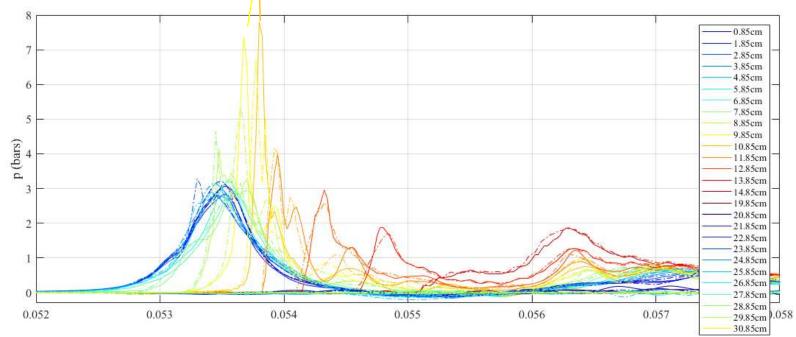
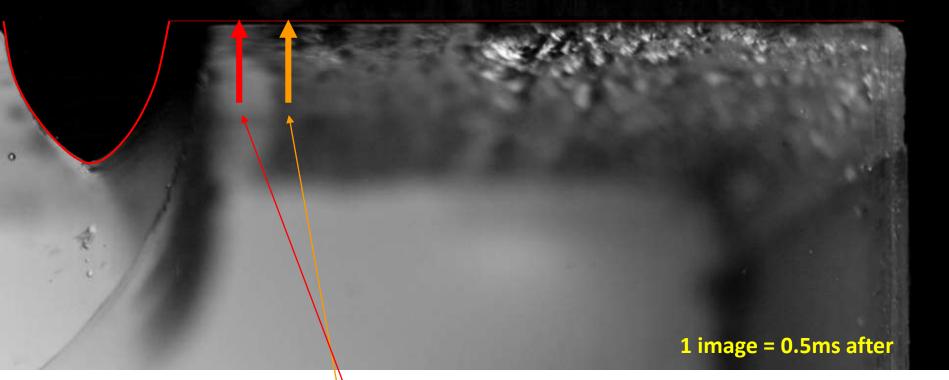
High pressures on the first part of the ceiling

Tests n°17 & 18, T₁=2.65s, H₁=0.300m, x₁=x_{wall}+0.75m, T₂=1.8s, H₂=0.115m, x2=x_{wall}-0.05m

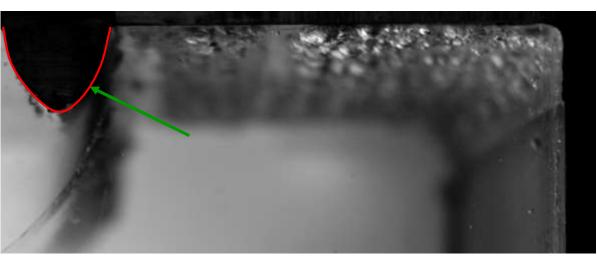
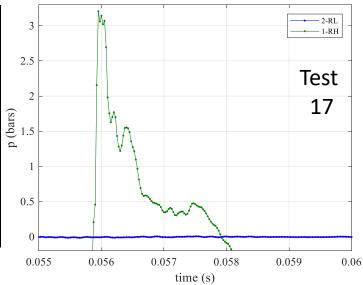
Impact on the corrugation

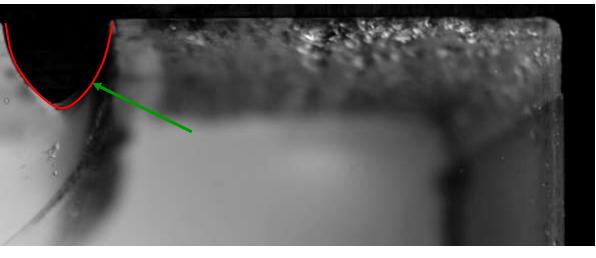
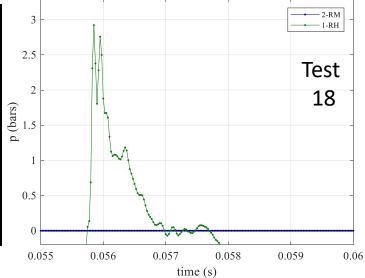
And repeatability

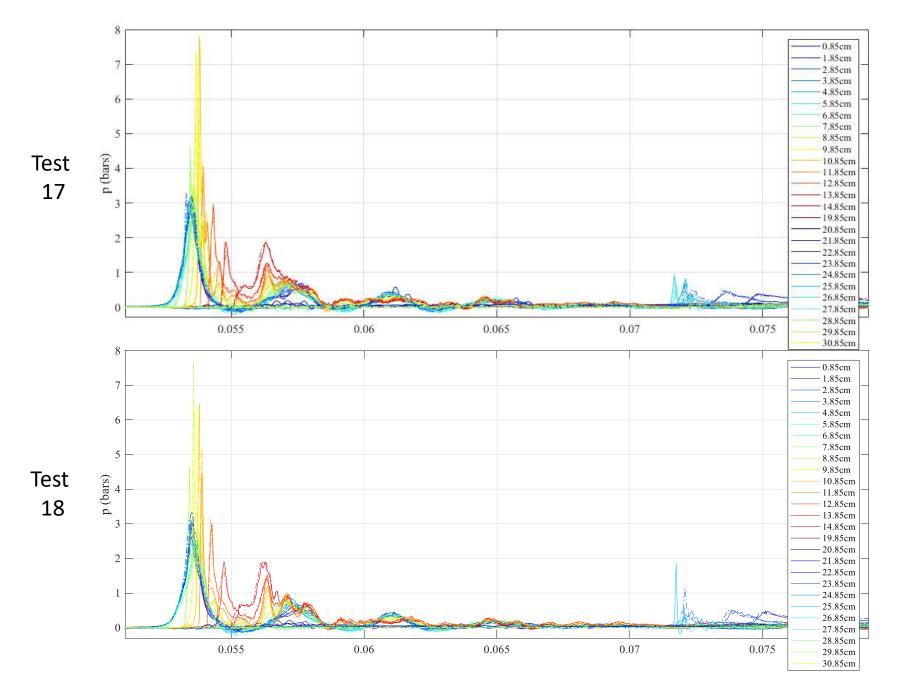
Repeatability

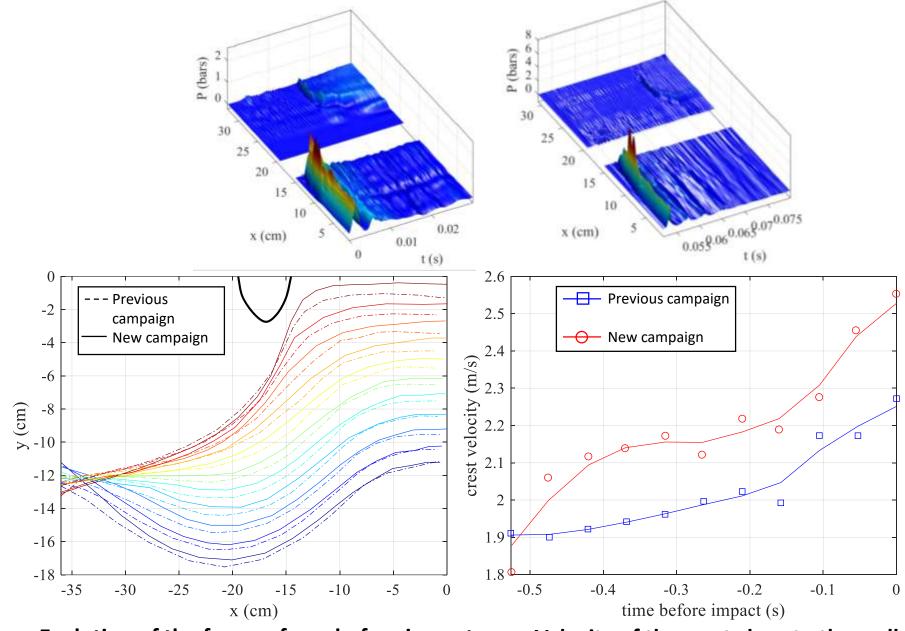
Comparisons with the previous campaign

Evolution of the free surfaces before impact

Velocity of the crest close to the wall

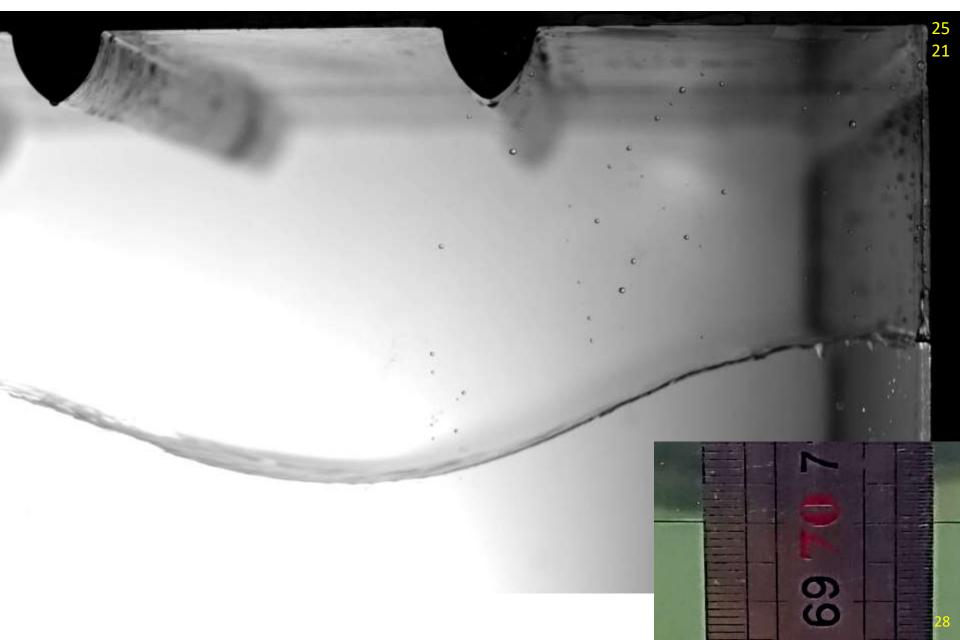
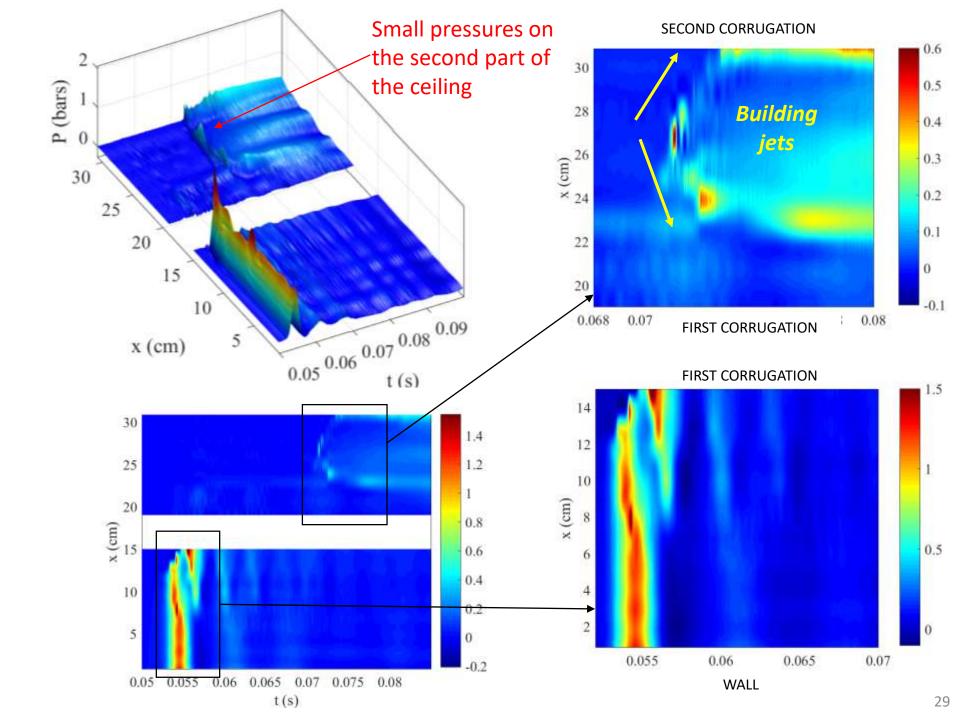
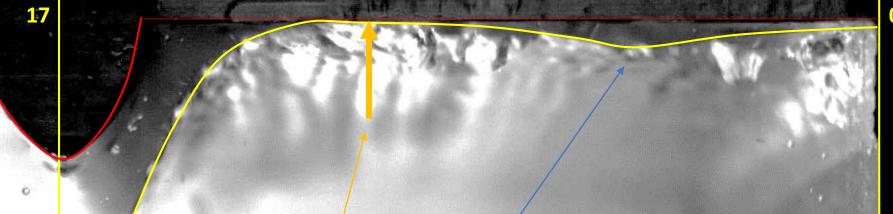
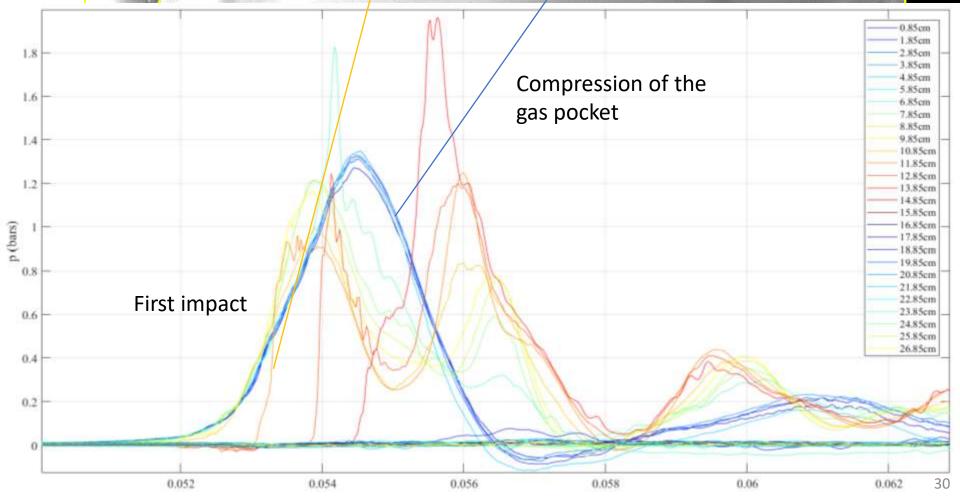
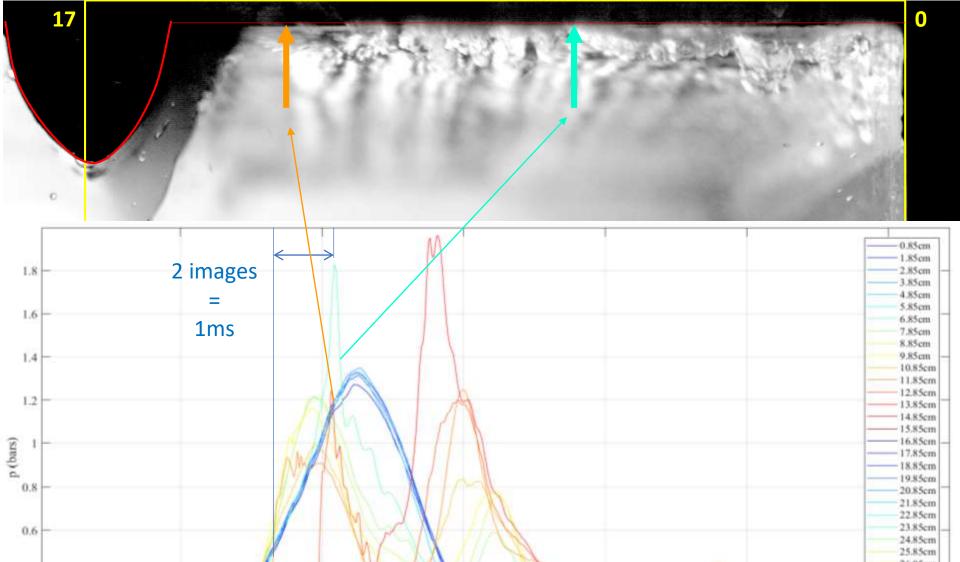
Impact close to the right side of the corrugation

Tests n°21 & 25, T₁=2.617s, H₁=0.300m, x₁=x_{wall}+0.75m, T₂=1.825s, H₂=0.11m, x2=x_{wall}-0.05m

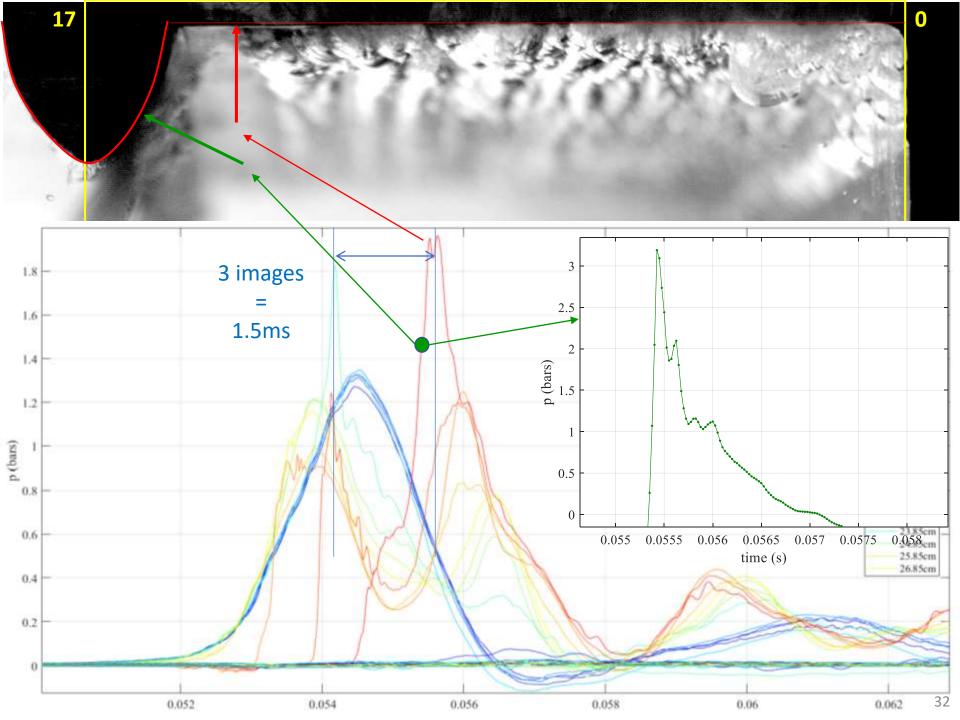
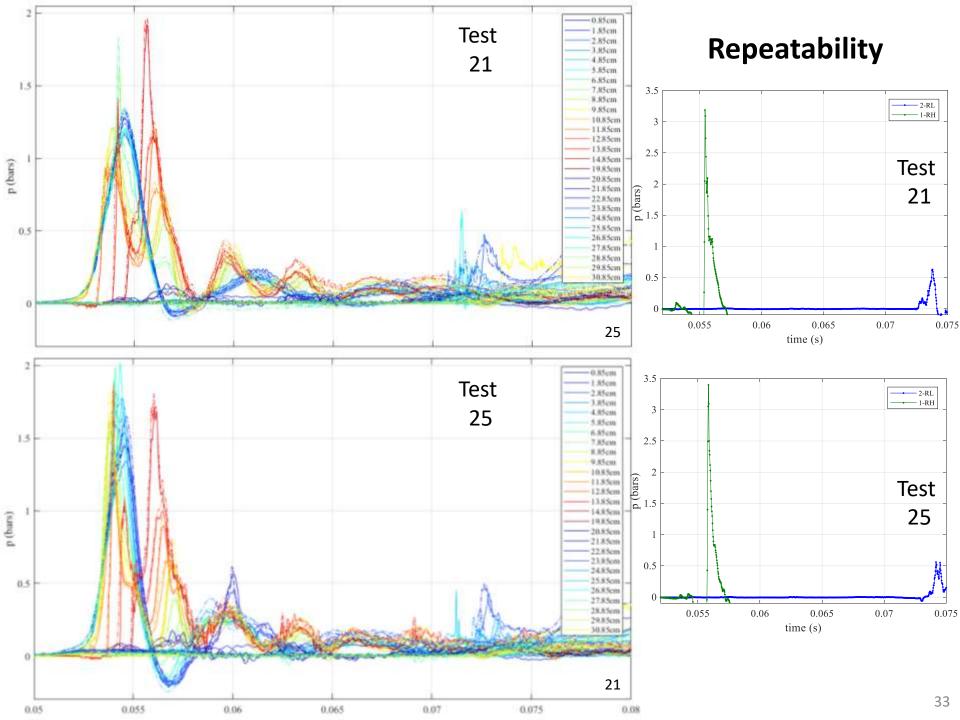
High pressures between the two corrugations

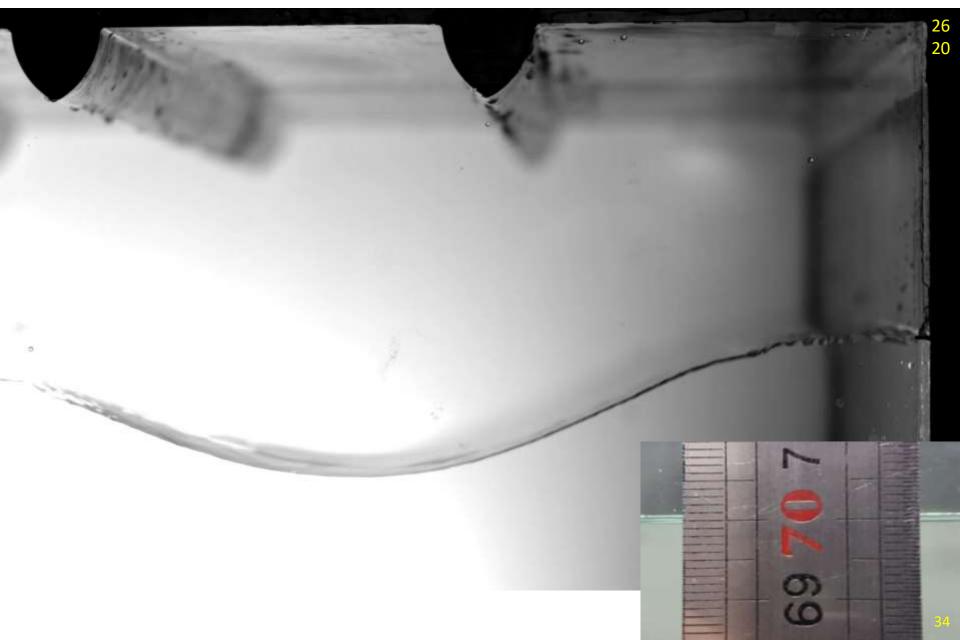
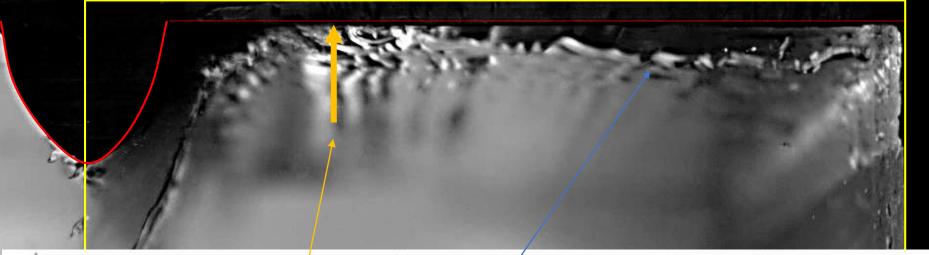
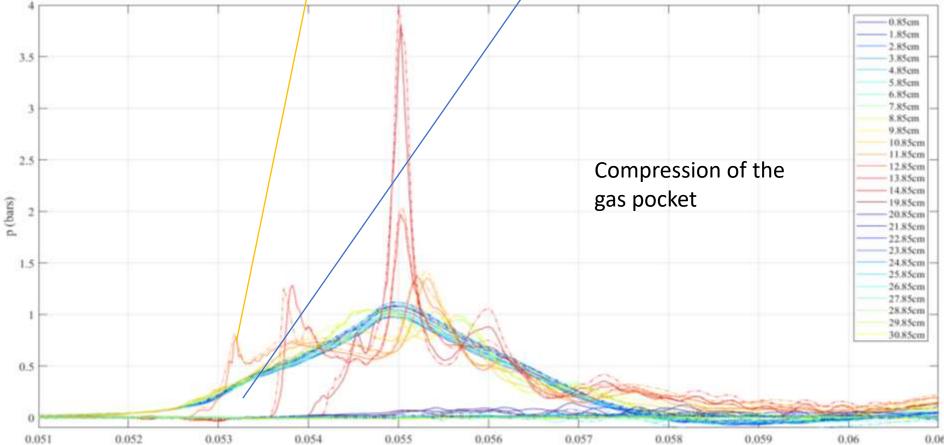
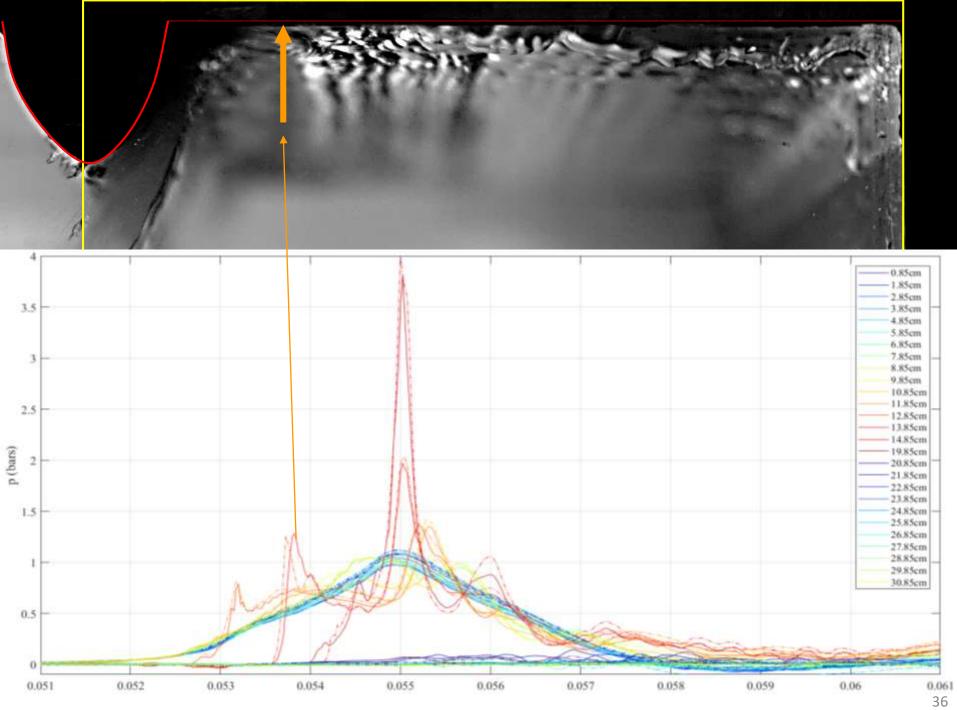
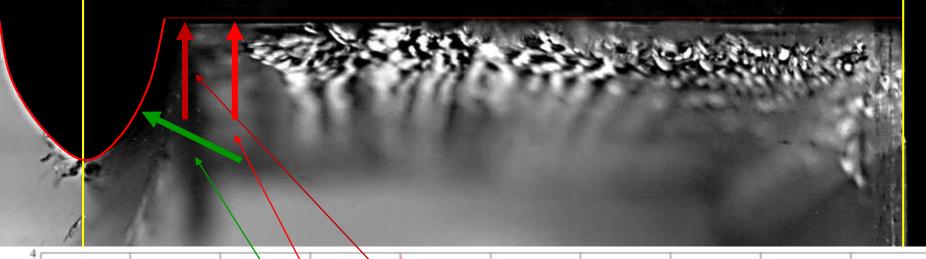
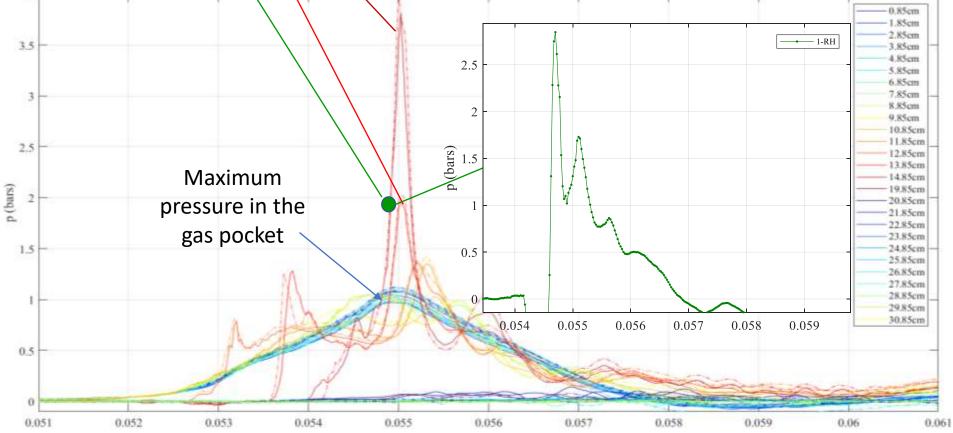
Tests n°20 & 26, T₁=2.617s, H₁=0.300m, $x_1 = x_{wall} + 0.75m$, T₂=1.825s, H₂=0.115m, $x_2 = x_{wall} - 0.05m$

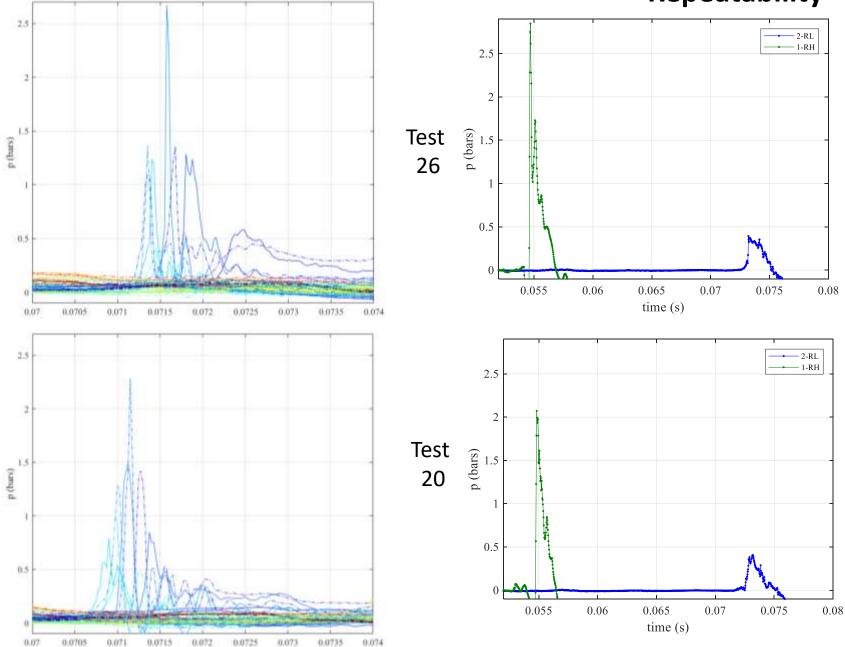
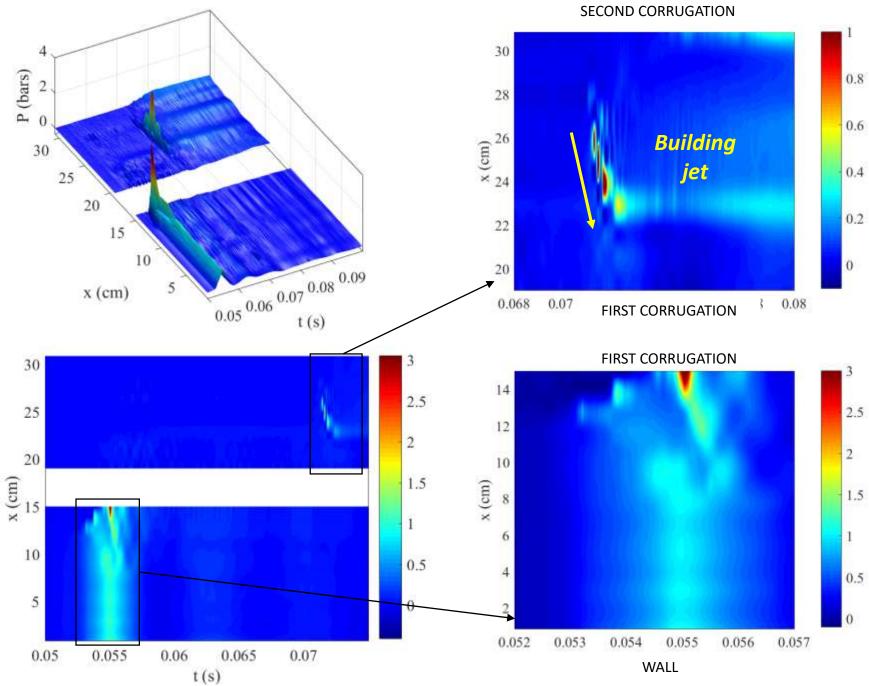
Repeatability
